BHP High Rise Controlled Cold Smoke Tests

Background

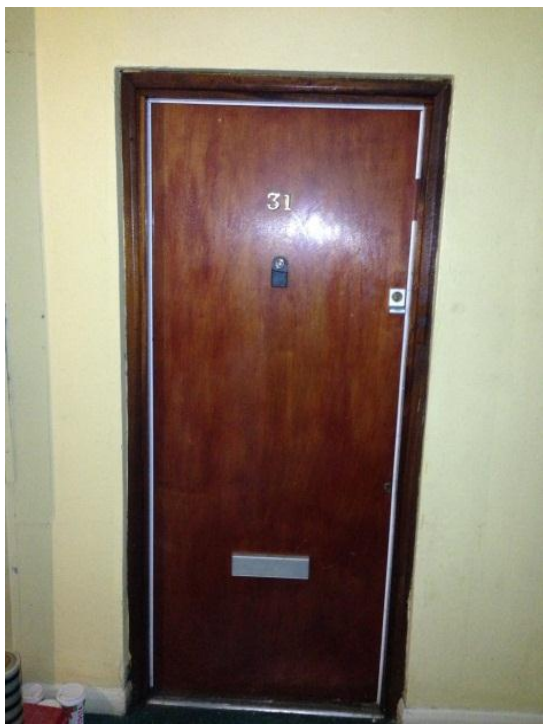
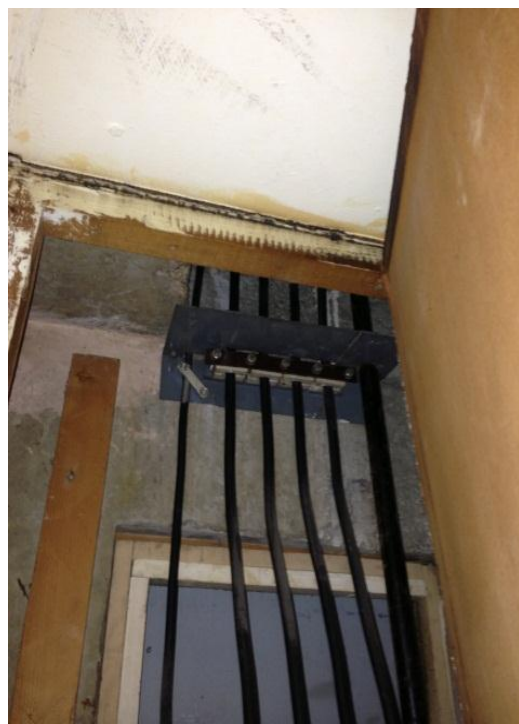
Flat 31

No modifications. The front entrance door is a solid core 44mm thick door, the door has no intumescent seals or smoke seals. There are compartment breaches from electrical services in a riser in a cupboard by the front door (pictured), pipes in a hallway cupboard and shared ducts in the bathroom.

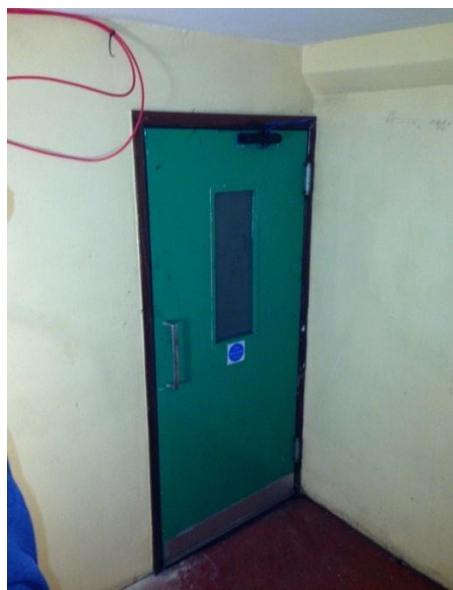
Communal stairwell (by flat 36)

No modifications, the communal door is a 54mm door with Georgian wire screen, the door had no intumescent seals and a brush smoke seal in typical condition for a door of its age. There is a potential breach to the compartment via a communal lighting junction box.

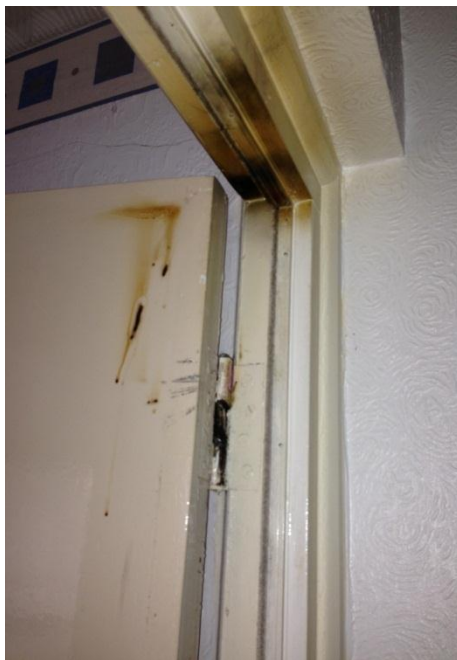
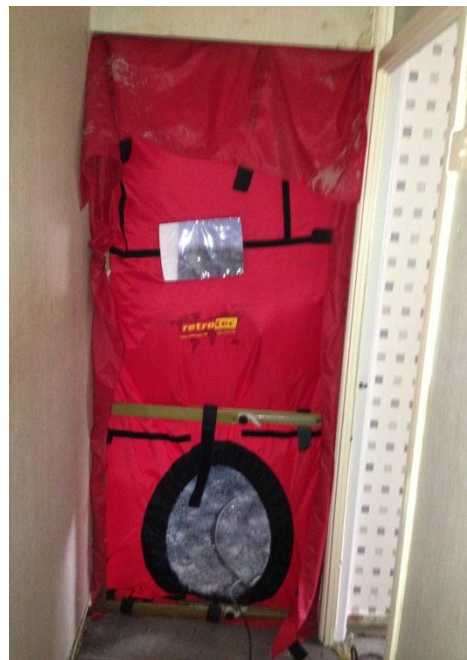
In the living room of flat 36 evidence of incense previously being burnt in the doorway was found (Pictured). For the purposes of these tests we decided to install the pressure unit in the living room doorway to simulate a fire started in this area (Pictured).
