## CHC Technical Conference

### DECC Solid Wall Research Project

# SWI Performance Unintended Consequences

## **Work Package 5**

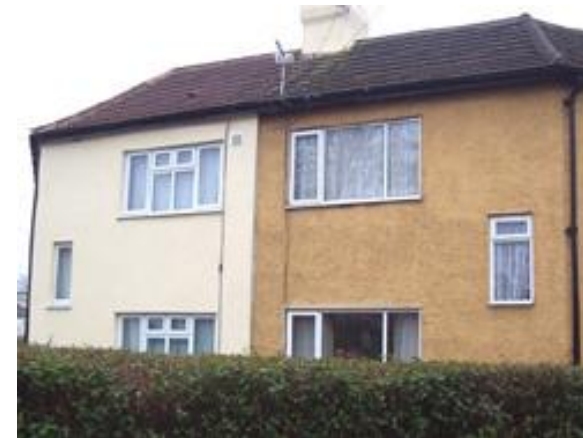
## Lampeter

- The properties within this original work consisted of a number of construction types, but all of solid wall, and a 3 build forms, houses, bungalows and flats, with 45% (75) being bungalows, 20% flats (32) and 35% (60) houses.
- All off gas, all social housing

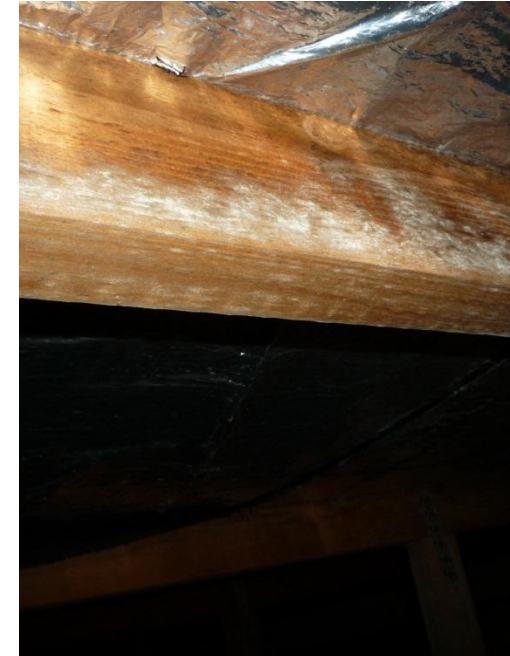
## Lampeter

- Condensation where none before, no consideration of ventilation.
- Buildings more air tight than before
- Work poorly sequenced
- Lack of detailed surveying before work undertaken

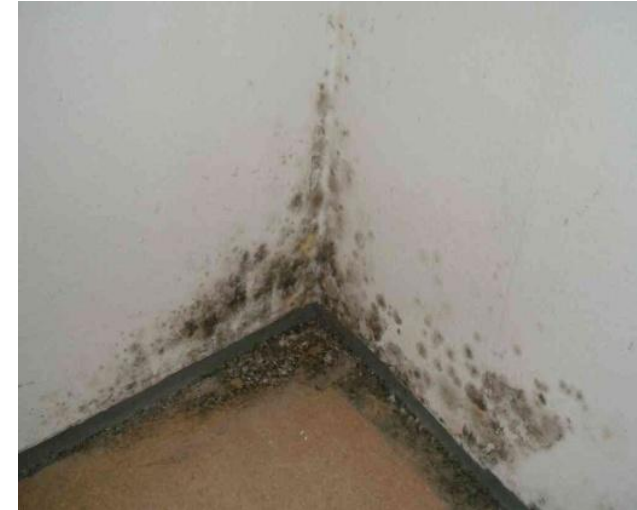
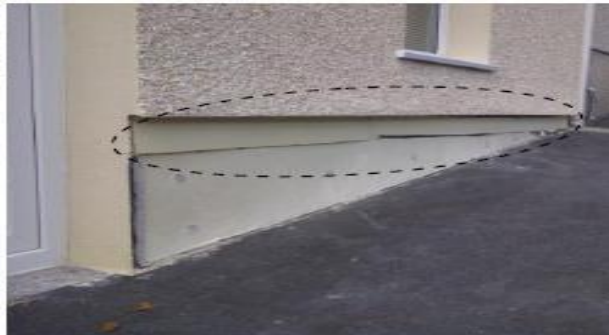
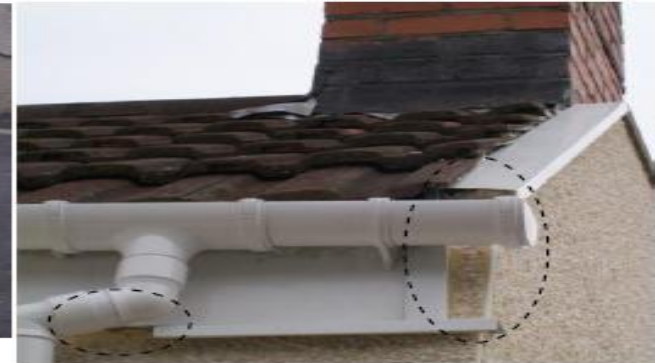
- Non insulated floor slab below plinth
- Condensation and mould in room corners

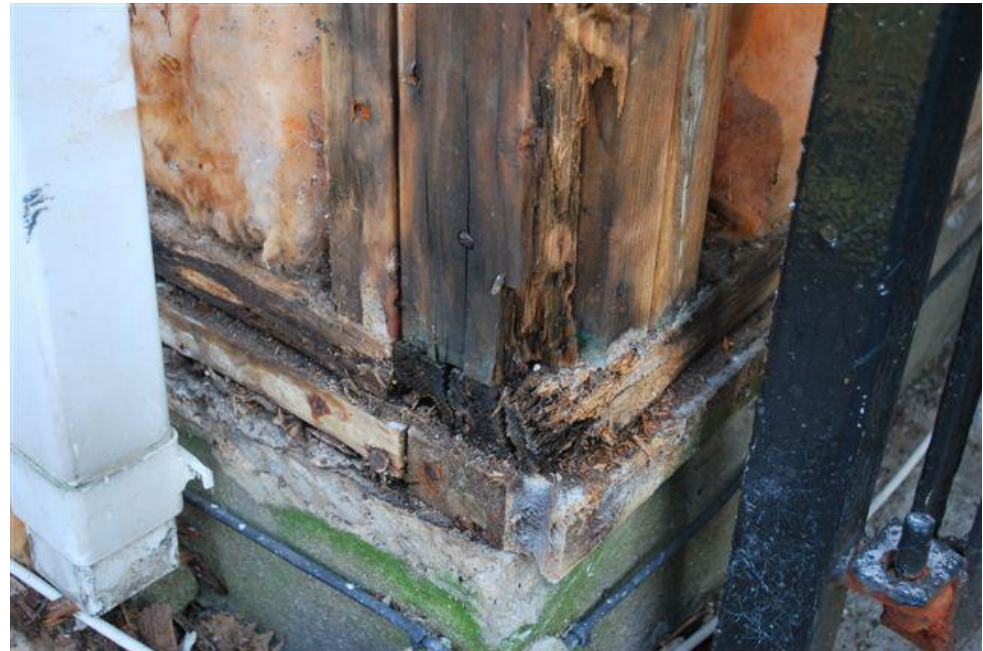
Timber Frame  
House

Built in 1967

Insulated in 2006

Wet rot, structural  
failure 2012

- water  
ingress

- poor  
detailing

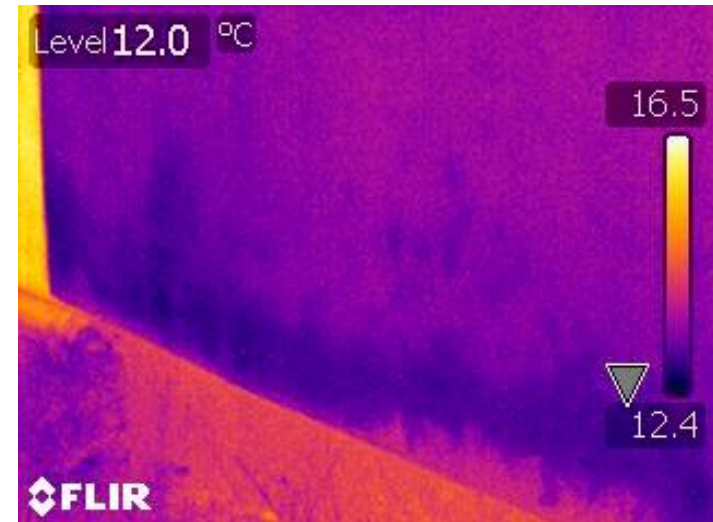
## Solid Wall in Lake District

- 250 years old
- Completed in January of this year
- Not exposed to high winds, but in high exposure area.
- System failing and saturated
- Starting to peel off

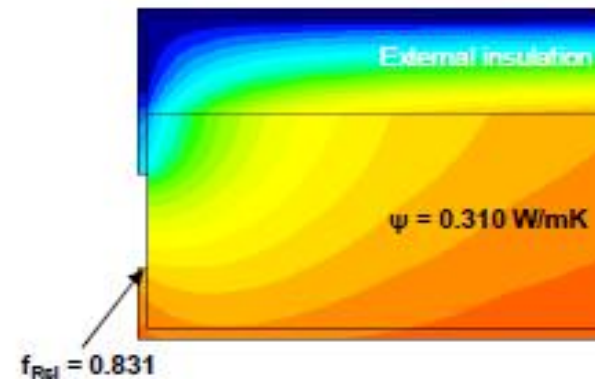
c: Jamb with 'typical' external insulation

- Initial modelling indicates if the reveals and heads etc are not insulated the psi value of the area becomes worse than before insulated.
- Risk shifted to areas least capable of dealing with them.
- Increased heat loss, and much higher risk of condensation and mould growth / failure.

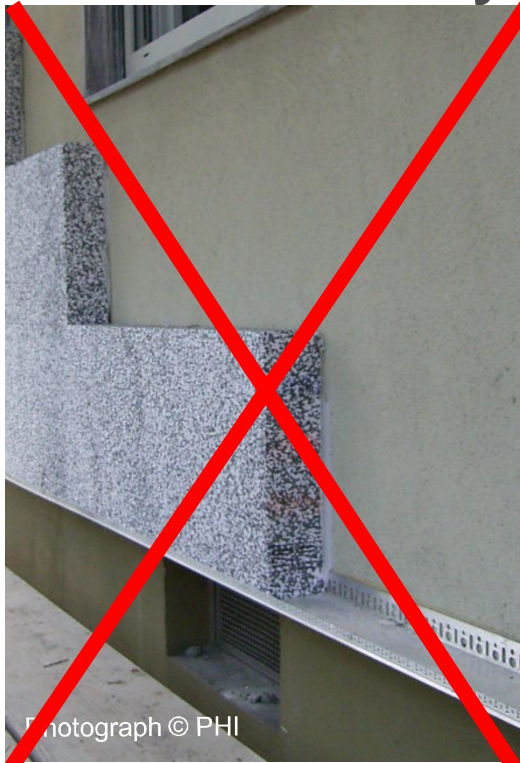
## Example: Aluminium profile at the plinth penetrating the insulation layer

Equivalent impact to leaving out 1.80 metre high strip of insulation!
