**Indicative hoarding fire
experiment**

Prepared for: London Fire
Brigade

Client report number 292366

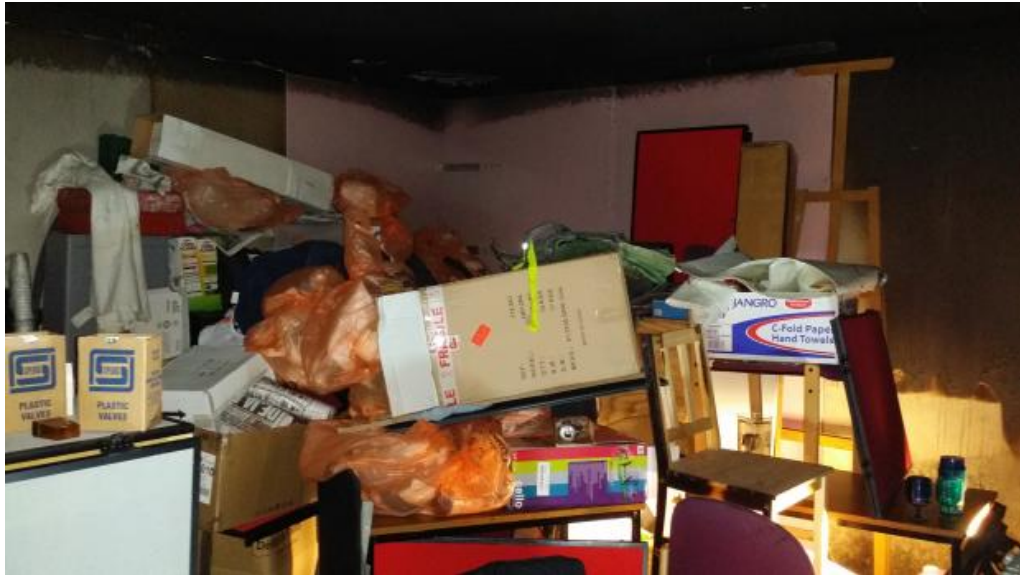
Figure 1 Hoarding material in the experimental rig

The experimental rig was filled with hoarding materials as shown in Figure 1. The contents comprised “household” material sourced by London Fire Brigade and included tables, chairs, cardboard boxes, clothing, papers, books, plastic bags of clean household waste, as well as a TV set.

The contents of the rooms were not weighed but were video recorded by BRE Global as each item was introduced. The camera was installed next to the door at about 2 m height.

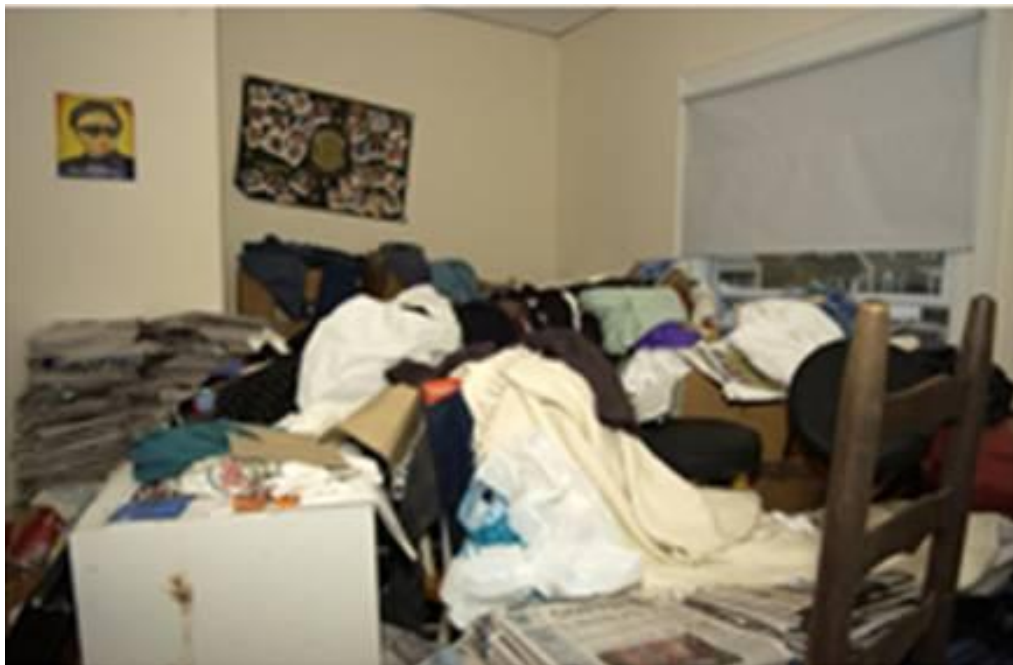
Figure 2 Level of hoarding material of Clutter Index 6

The hoarding material was provided by London Fire Brigade and installed by them to a level defined in the Clutter Index, i.e. nominally Clutter Index 6 bedroom as shown in Figure 2 and also described in:

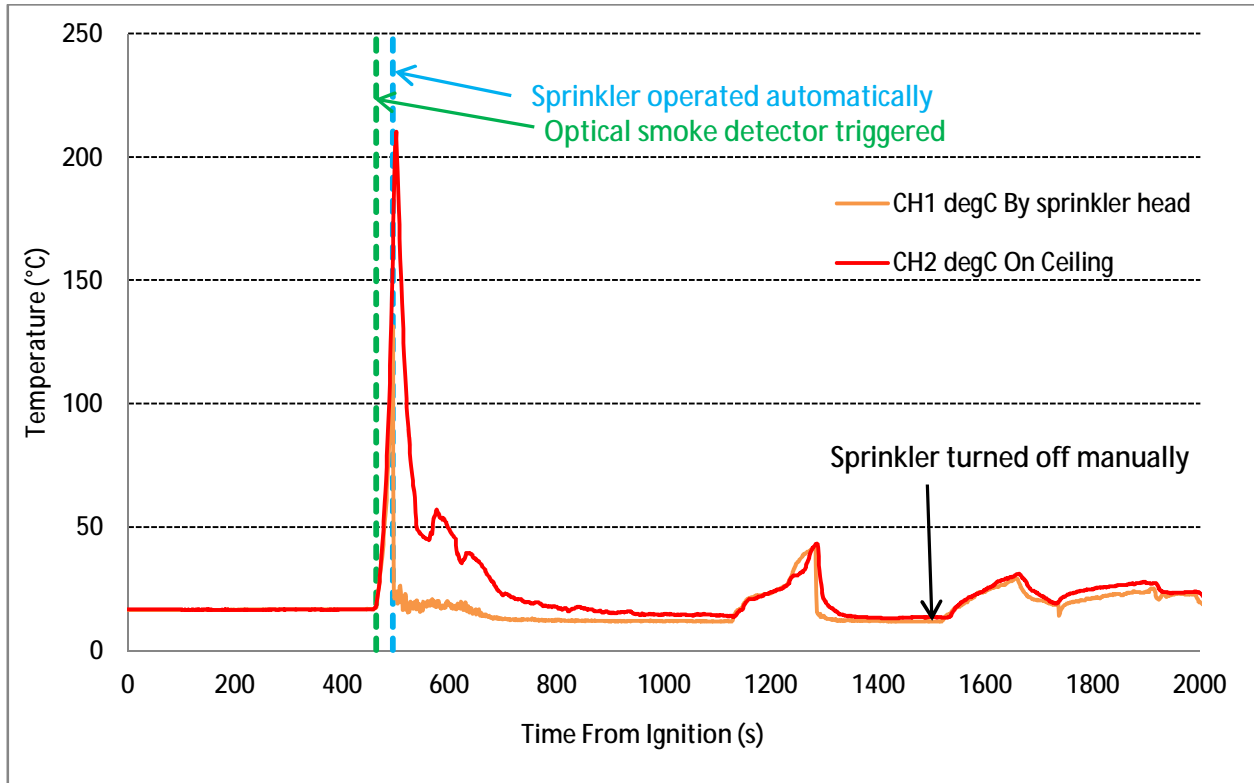
Figure 5 Temperature data measured at sprinkler head and ceiling

Figure 5 shows temperature data measured at the ceiling and at a point adjacent to the side wall sprinkler head. From ignition to around 400 seconds, there was no temperature rise measured. During this period a small amount of smoke was observed floating in a thin layer near the top of the room and gradually spilling out from the room. It was noted that while smoke was produced in the early smouldering stage of the ignition, it did not have sufficient momentum to overcome the warm layer at the ceiling and as a consequence the optical smoke detector did not operate, despite smoke clearly being present. At about 464 seconds (7 minutes 44 seconds) from ignition, the optical smoke detector activated and the measured temperature at the sprinkler head and at the ceiling level rose significantly. At 494 seconds, some 30 seconds from smoke detector activation, the side wall sprinkler operated. The temperatures measured at the sprinkler head and at the ceiling were 131.3 °C and 162.4 °C respectively.

The sprinkler was initially operated with a flow of 53 litre/min which corresponds to 3.3 mm/min. At 734 seconds (4 minutes after sprinkler operation) the flow was increased to 57 litre/min which corresponds to 3.6 mm/min.

The operating sprinkler significantly reduced the temperature in the room. Steam and smoke were observed spilling out of the room throughout this period.

At 1,130 seconds from ignition (approximately 10 minutes after sprinkler operation), it was agreed that the sprinkler would be temporarily turned off, to represent a 10 minute duration of available water. As shown in Figure 5, the temperature rose gradually. Consequently, the sprinkler was turned on again 2.5 minutes later, when the temperature decreased to the previous level. While the sprinkler was off much of the cool smoky steam cleared from the room; the gradual increase in the ceiling temperature indicated the potential for further fire development within the room.

To observe the spray characteristics from two operating sprinklers (which shared the water supply), at 1,394 seconds (15 minutes after sprinkler operation), the second sprinkler was manually operated and the total flow was increased to 105 litre/min which corresponds to 7 mm/min.

At about 1,544 seconds (17.5 minutes after sprinkler operation) the sprinklers were turned off. As shown in the figure, the temperature rose slightly. The remaining fire was manually extinguished.

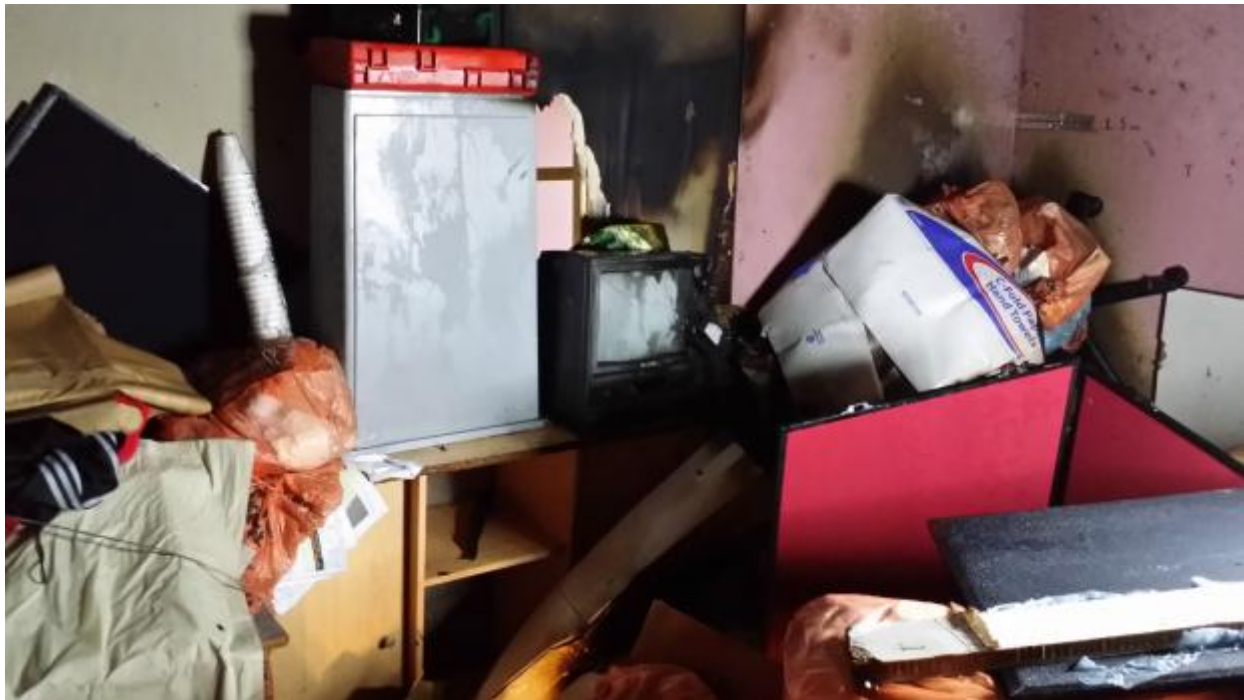
Figure 6 Post-fire damage

Figure 6 shows post-fire damage.

Although the flames were observed to impact the ceiling, the fire did not spread significantly beyond the ignition point before the sprinkler operation occurred.
