BHP High Rise Controlled Cold Smoke Tests

Background

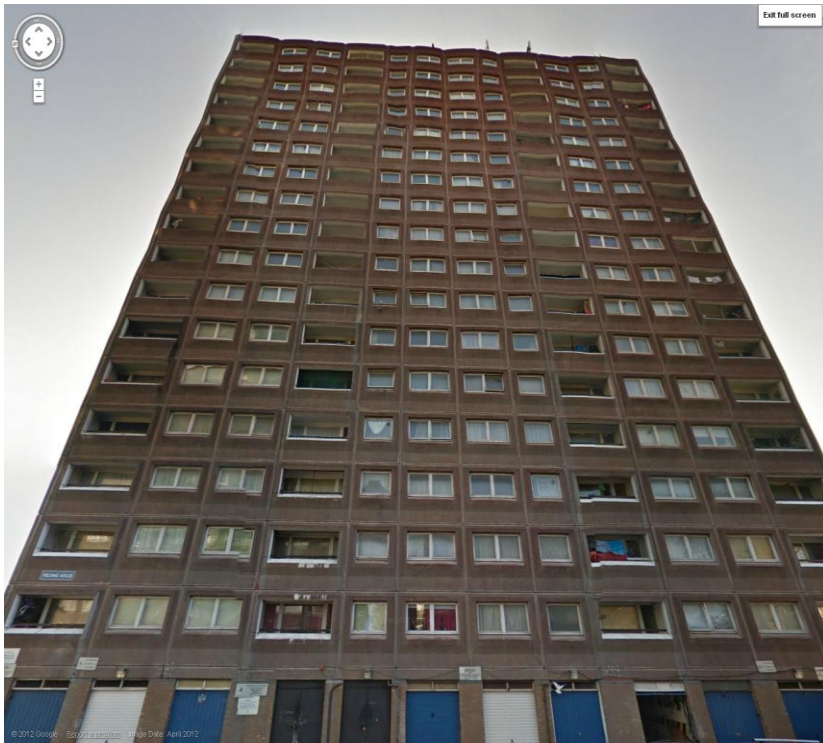
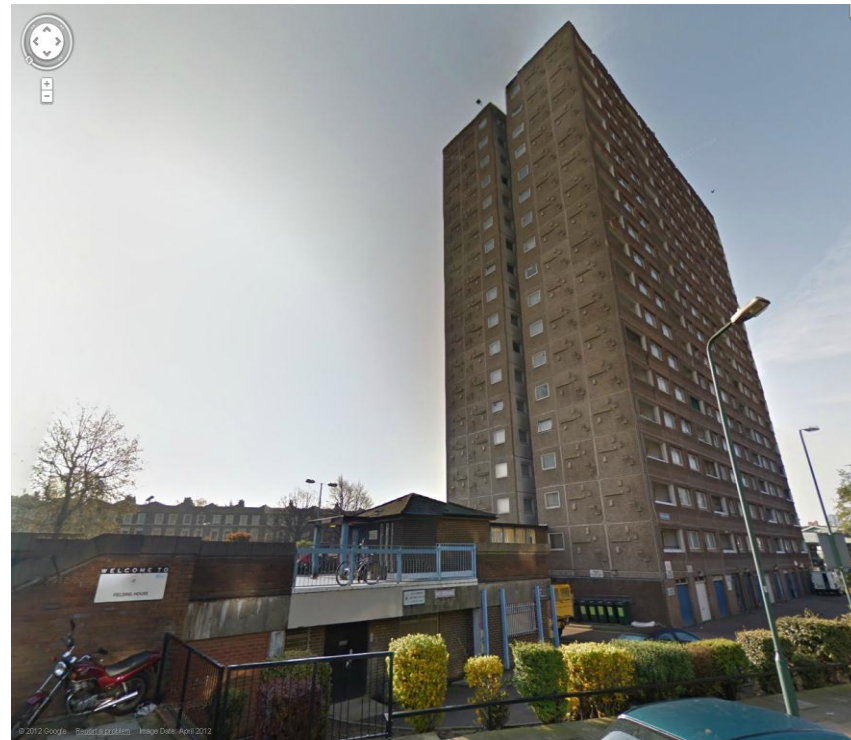
External Views

Fielding House, Cambridge Road, Kilburn is an eighteen storey high rise tower block. The construction type is a bison block made of reinforced preformed concrete panels. The block consists of one hundred and sixty seven flats and two enclosed staircases.
